Motivo de consulta:

Mujer de 29 años que acude a urgencias por dolor abdominal en FII.

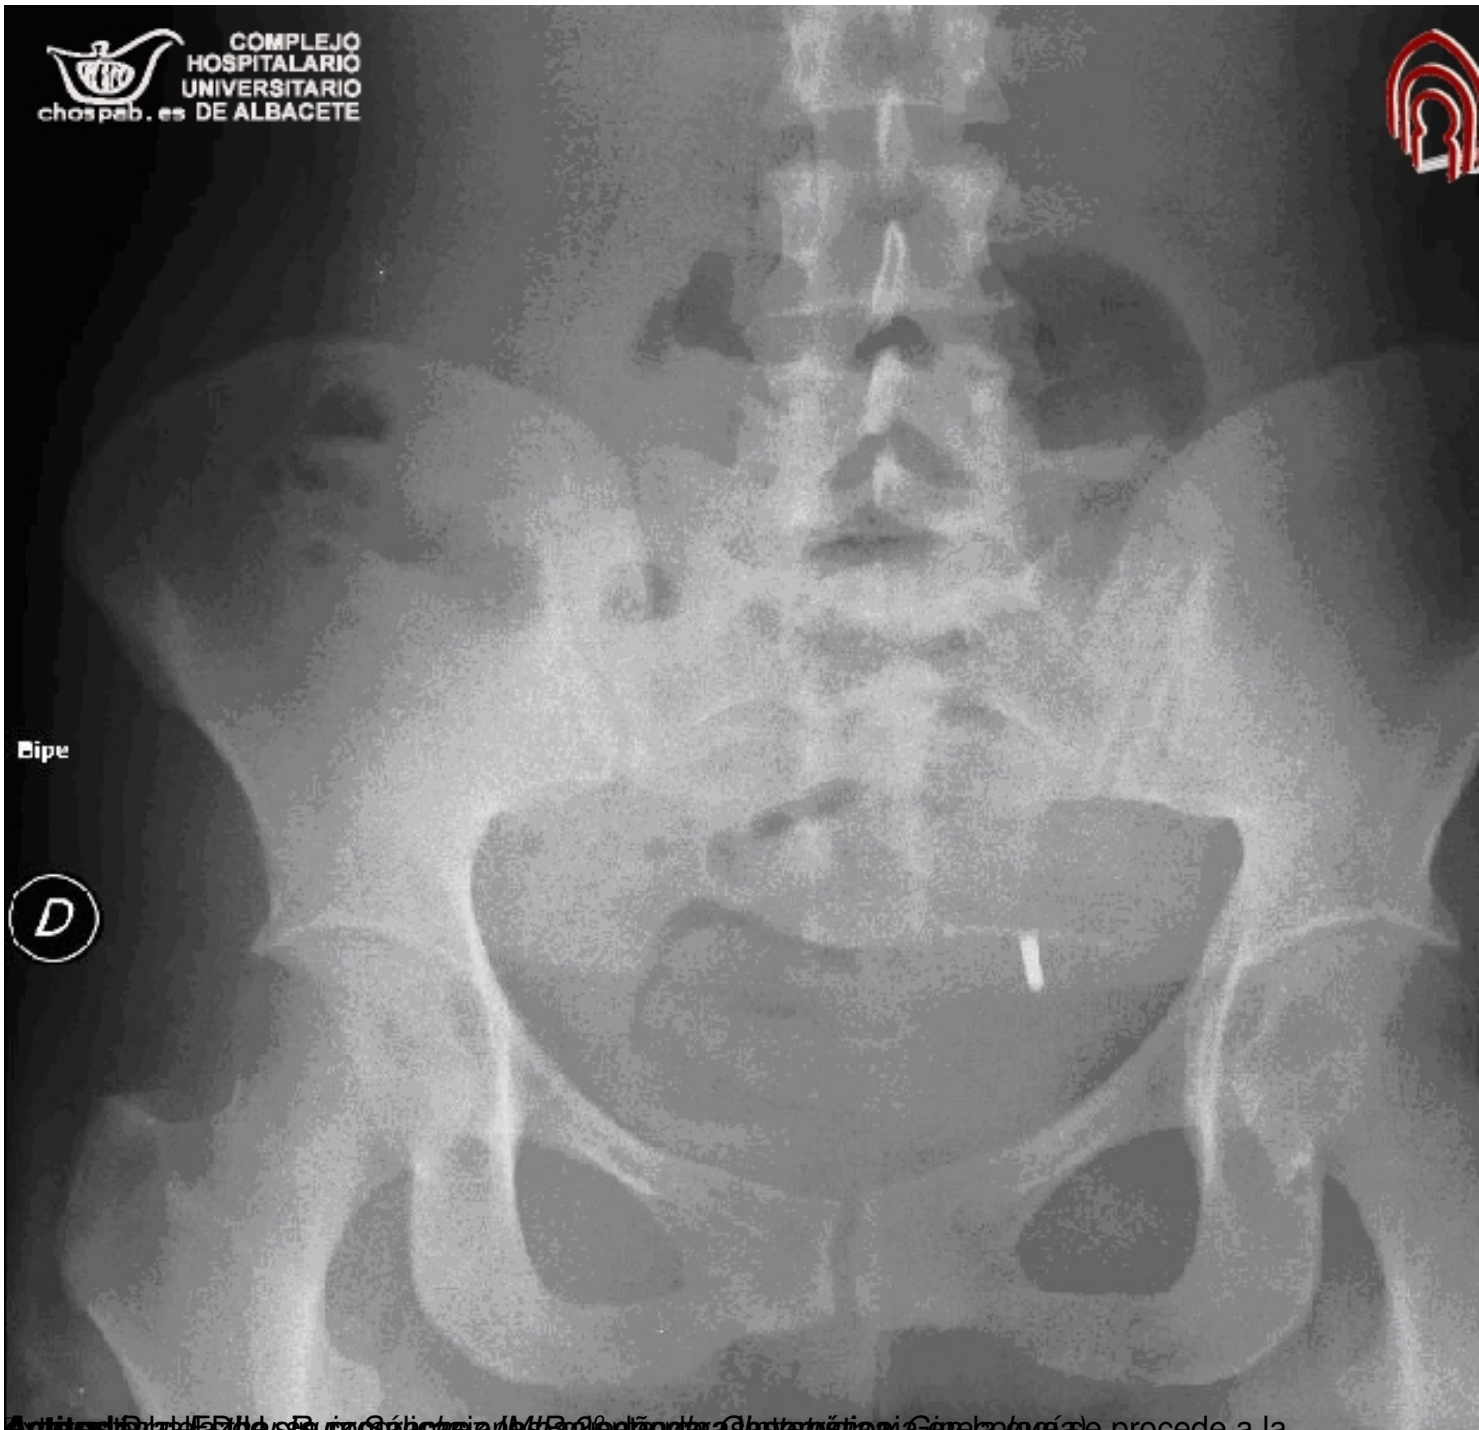
- **Ecografía transvaginal:** No se objetiva DIU en cavidad uterina. Aparato genital normal.
- Se solicita **radiografía de abdomen**, localizando el dispositivo fuera de cavidad uterina.

Anteroposterior (AP) radiograph of the pelvis. A migrated Intrauterine Device (IUD) is visible in the right hemipelvis. The IUD is a small, bright, linear object located in the right iliac region. The rest of the pelvic bones and the lumbar spine are visible. The image includes a logo for 'COMPLEJO HOSPITALARIO UNIVERSITARIO DE ALBACETE' in the top left, a red logo in the top right, and a 'D' marker on the left side.

Exploración ginecológica normal, excepto no visualización de hilos de DIU. Abdomen blando y depresible, doloroso a palpación profunda en FII, sin signos de defensa, ni irritación peritoneal.
